**6229 Tryon Road
Cary, NC 27518***Summarization for:***Client Name****Client Address****September 6, 2008****Page 1 of 3**

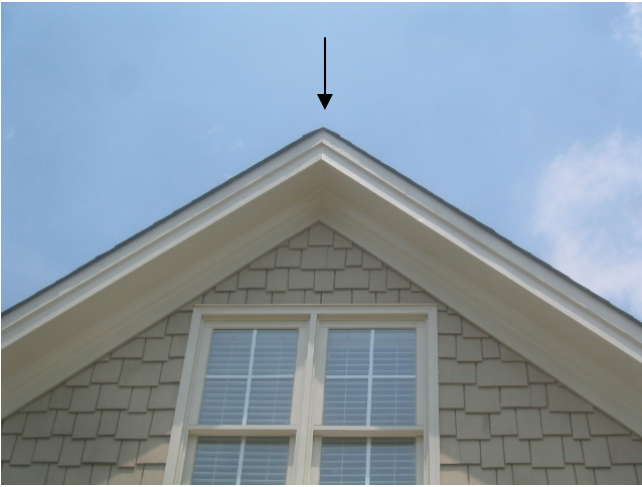
1. The garage gable roof end ridge cap shingle is damaged (there is a small hole in this shingle at the peak), visible from the driveway. This condition will allow rainwater leakage that could result in eventual moisture damage to the roof trim or roof sheathing near this area. Recommend that a qualified repair contractor make necessary repairs. (see photo)

Garage gable roof end ridge cap shingle is damaged

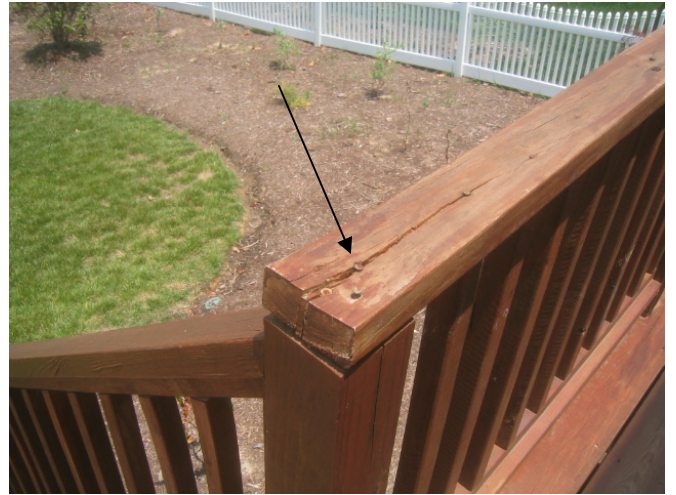
2. The rear deck rear right handrail upper rail (horizontal 2x4 board) is split and is warped at the left end, located at the right side of the deck steps. These conditions may cause personal injury to someone using this handrail. Recommend that a qualified repair contractor make necessary repairs for safety. (see photo)

Rear deck rear right handrail upper rail is split and warped

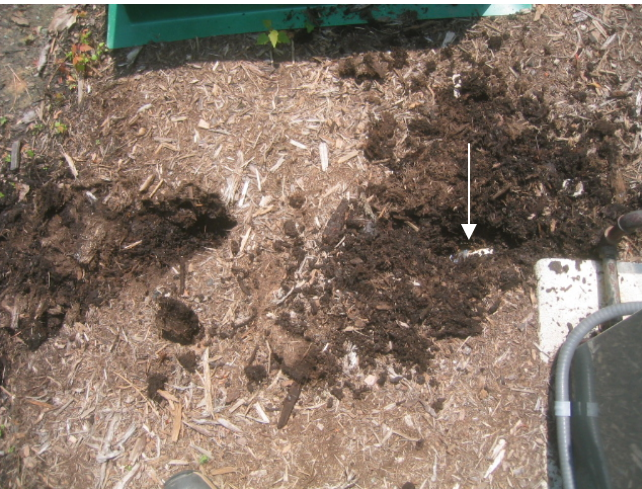
15. The right side gas pack unit air conditioning condensate drainpipe disappears under ground beside the unit, and the exit opening is not visible. The exit opening was located by excavating down through the pine bark mulch. This drainpipe is required to exit to daylight with no restriction for the free flow of condensate water. This needs repair to help ensure the proper operation of the first floor air conditioner. (see photo)

Gas pack air conditioning condensate drainpipe does not currently drain to daylight

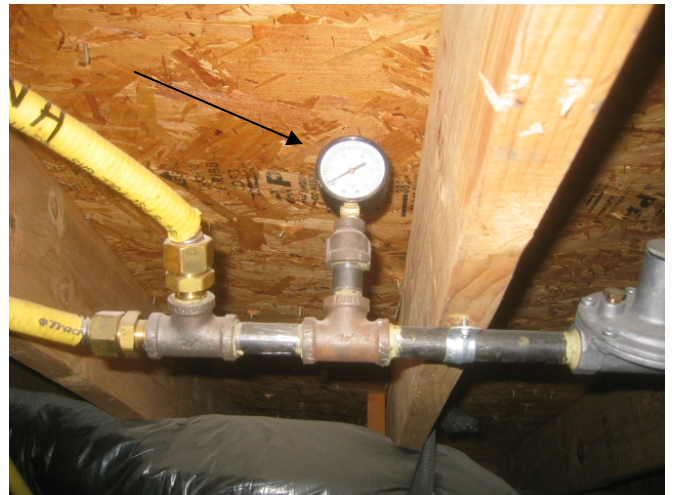
18. One natural gas supply pipe manifold has a temporary pressure gauge still installed, located in the attic behind the furnace and water heater area. This pressure gauge is not designed for permanent installation, and may eventually fail, resulting in a gas leak. Recommend that a licensed mechanical (HVAC) contractor or other qualified repair contractor remove this gauge and install the appropriate end cap on this gas pipe (and verify that there are no gas leaks after repair) for safety, and to comply with accepted building standards. The gas water heater pilot light will need to be relit after the natural gas supply is turned off for this repair. (see photo)

Attic natural gas supply manifold has a temporary type pressure gauge still installed
